Briefing on Bay Bridge Bolts – June 6, 2013

THE SAN FRANCISCO-OAKLAND
BAY BRIDGE
SEISMIC SAFETY PROJECT

Metallurgical Report on 2008 Bolts, Dated May 7, 2013

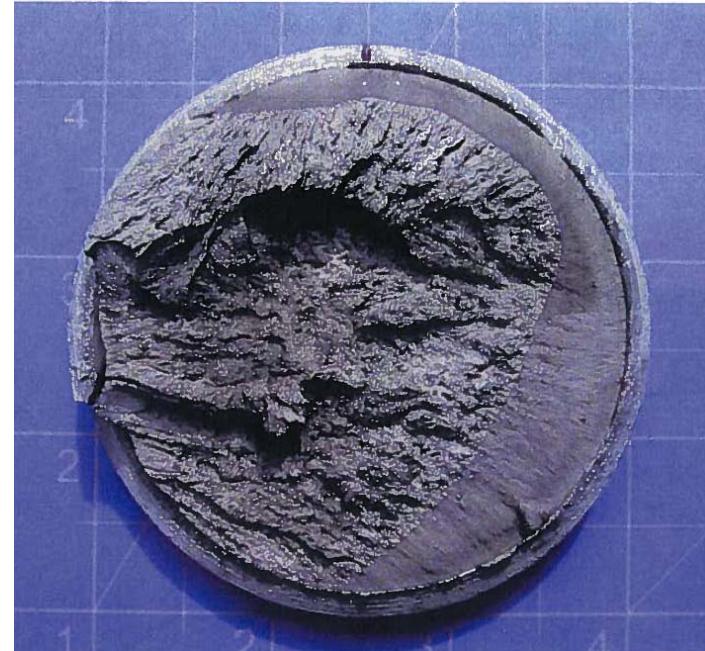
- The root cause of the failures is attributed to higher than normal susceptibility of the steel to hydrogen embrittlement.
- The metallurgical condition of the 2008 bolts was found to be less than ideal with large differences in hardness from center to edge, and high local hardness near the surface. The material also exhibited low toughness and marginal ductility.
- The combination of all of these factors caused the 2008 anchor rods to fail due to hydrogen embrittlement.

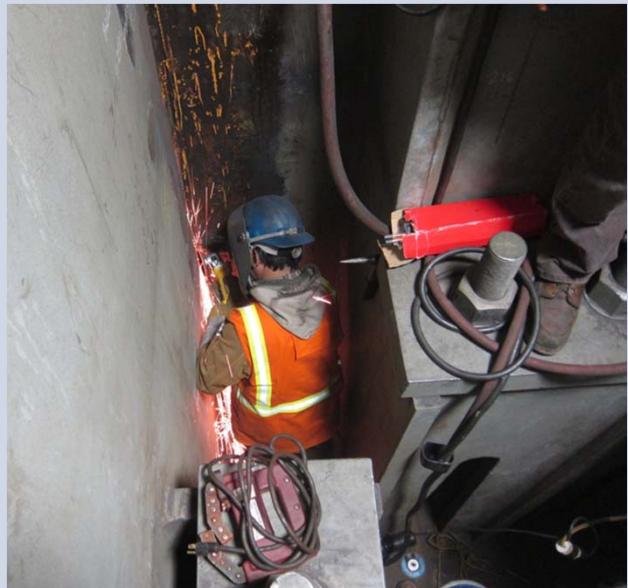
Challenge	
<p>1. Electroslag Welding at Tower Base</p> <ul style="list-style-type: none">• Inspectors have found a number of imperfections in electroslag welds at the base of the tower.• Engineers are methodically mapping welds and determining which imperfections must be removed and replaced with quality weld material to ensure that all weld capacities exceed seismic demands for the 1,500 year design motions.• The process has been underway for about nine months, and is continuing.

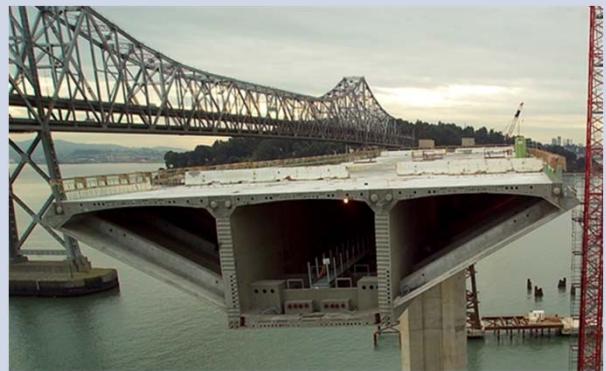
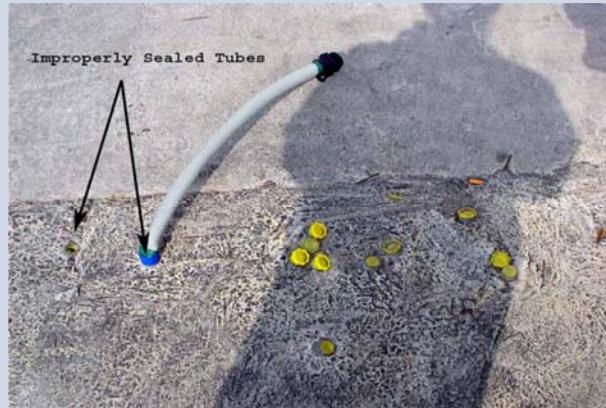
Challenge	
<p>2. Skyway Tendon Corrosion</p> <ul style="list-style-type: none">On the skyway portion of the bridge, concrete sections are clamped together with internal steel cables known as pre-stressing tendons.Grouting of the pre-stressing was delayed, after inspectors learned that pumping grout in one tube could potentially get into another tube, clog it, and prevent a cable from being installed.Engineers conducted inspections and discovered grout vents had been broken and not repaired. Rain water entered the vents and partially filled the pre-stressing ducts leading to some steel corrosion. Additional inspections and lab testing were done and it was concluded the steel was within tolerance for successful use.

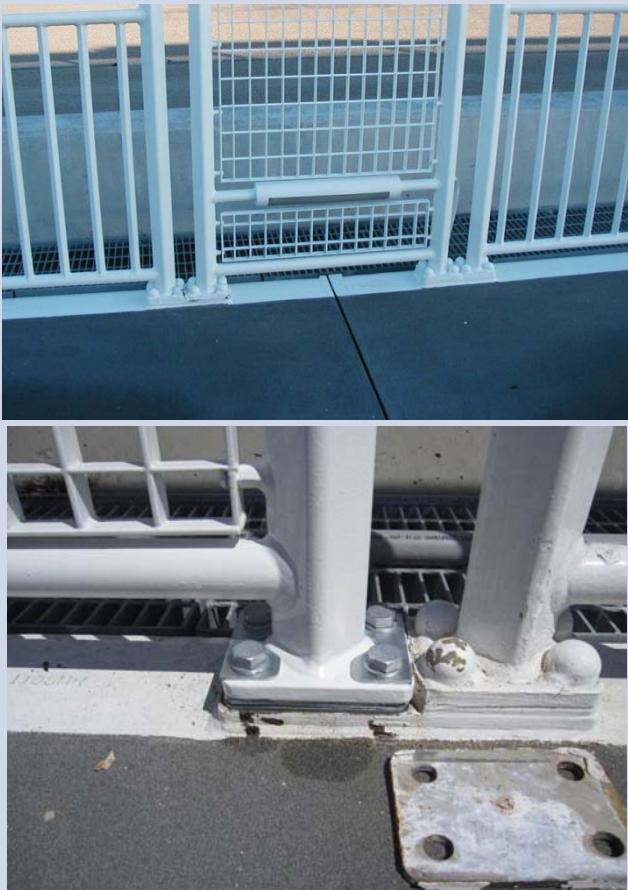
Challenge	
<p>3. Bike Path Connection</p> <ul style="list-style-type: none">• While removing divider rails to make electrical and shimming modifications, Caltrans observed that some bolts securing the rails to the deck had been sheared, likely by thermal movement of the deck.• The bolted connection was restrained from thermal expansion and contraction by an oversized weld of architectural bolt caps to the base plate.• To resolve the problem, all divider panel bolts were removed, railings were modified with larger slotted bolt holes in the base plate and bolt caps were eliminated.• The railing work has been completed, it was estimated that 10% of over 2000 divider bolts may have had this problem.

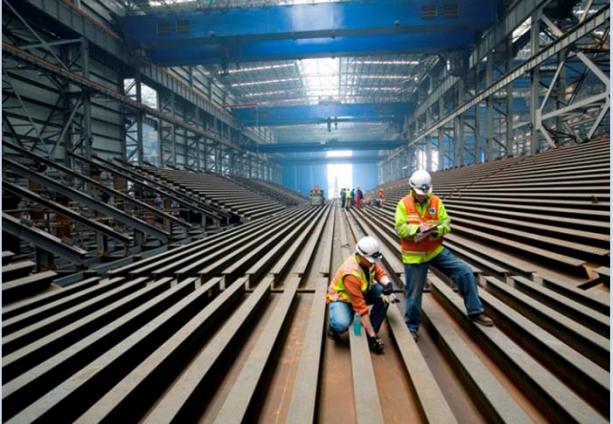
Challenge	
<p>4. Roadway Box Welding</p> <ul style="list-style-type: none">• Over the course of the project, weld quality has been raised and reported upon several times.<ul style="list-style-type: none">• In 2008, inspectors found cracks in welds of deck plates in China. Supplemental testing was instituted and all cracks were repaired.• In 2008 to 2010 time period, field welding of deck segments in the Bay was not achieving required tolerances for planar alignment. Analyses were performed and repairs were made.• The challenges were reported to the Oversight Committee and in monthly reports.• The challenges were vetted by the Seismic Peer Review Panel and documented in a report in March 2011.

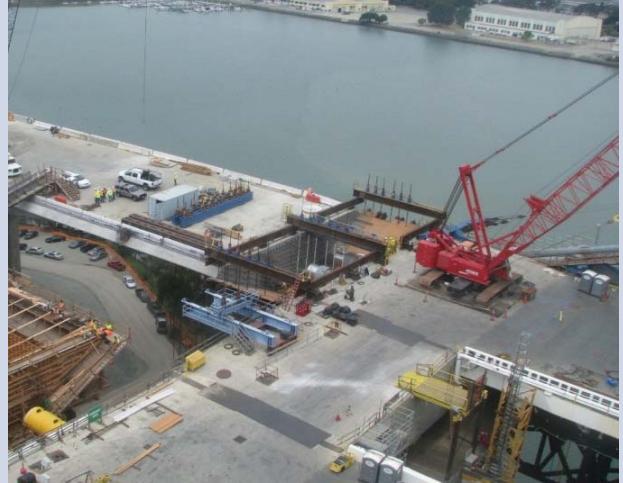
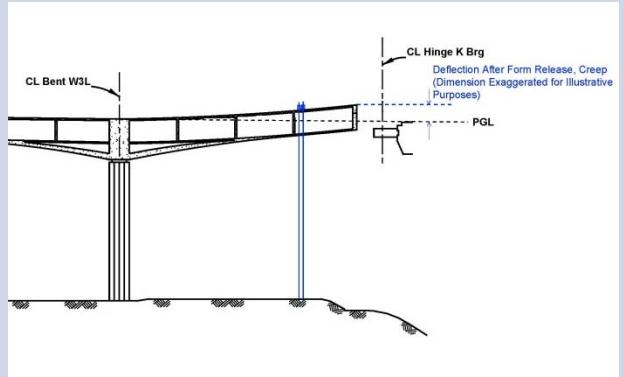
Challenge	
<p>5. YBI/SAS Deck Alignment</p> <ul style="list-style-type: none">The concrete section of the bridge between the Self-Anchored Suspension span and Yerba Buena Island was a few inches higher than the suspension bridge deck. The added elevation was due to the pulling forces of the imbedded pre-stressing tendons.Engineers carefully considered several options.The steel ballast option was selected as best alternative.
